Influence of deep seated discontinuities on the left slope of Jinping I Hydropower Station and its stability analysis

Shengwen Qi · Faquan Wu · Yuande Zhou ·
Yuhuan Song · Manfu Gong

Received: 23 April 2009 / Accepted: 12 January 2010 / Published online: 30 March 2010
© Springer-Verlag 2010

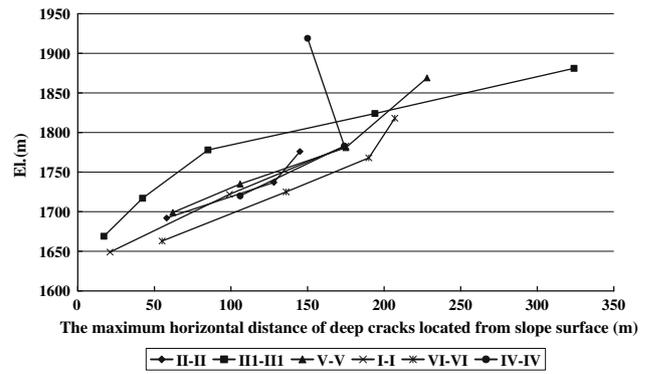
Fig. 6 The maximum horizontal distance of deep cracks located from the slope surface increasing with high elevation

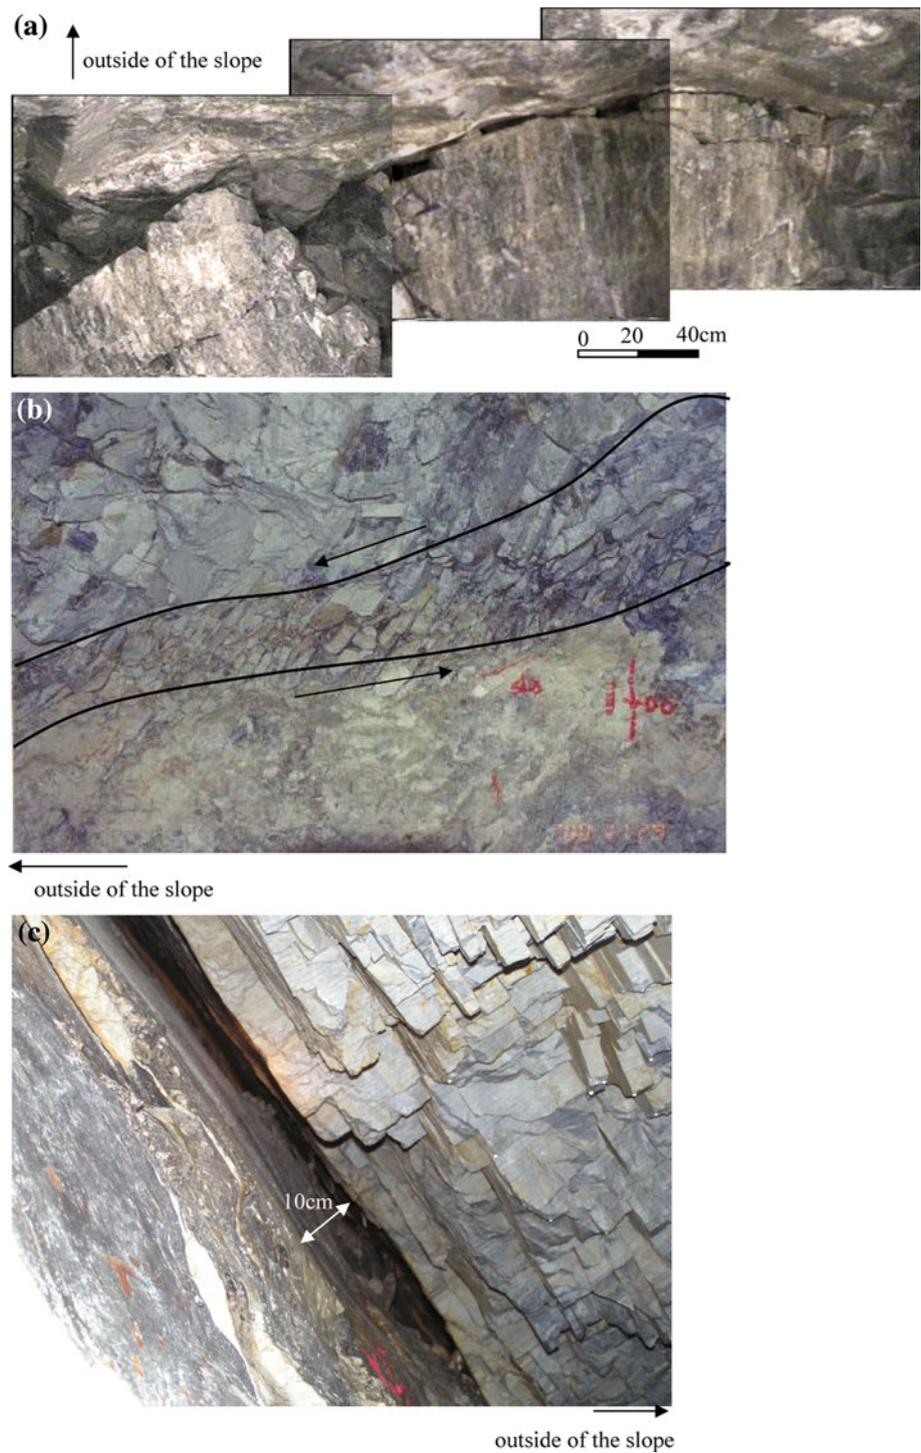
asperity the rock will be in close contact e.g. SL15 (see Fig. 7a). In some places there are many closely spaced fresh fractures with an aperture of 10–20 mm (e.g. SL3, Fig. 7b), whilst in others there is a single large crack with an aperture of 50–200 mm (e.g. SL14, Fig. 7c). The deep cracks dip outward towards the slope face; the dominant dip direction is N120°–160° at a declination of 50°–60° (similar to the Set 2 joints); a few of the deep cracks have a slightly different attitude with a dip direction of 160°–175° and an angle of 60°–80°.

Fig. 7 Shape of deep cracks:
a part of deep crack of SL15;
b part of deep crack of SL3;
c part of deep crack of SL14

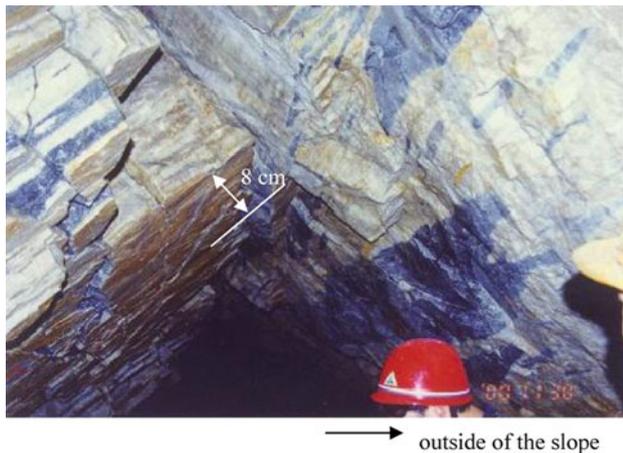
movement appears to have occurred with gravity due to movement in the near surface rocks (e.g. SL24, Fig. 8). Observations in the adits and seismic tomography indicate that the deep cracks extend up to 180 m in their strike direction and up to 60 m in the dip direction. As noted above, the deep cracks are found up to 350 m from the valley side; the horizontal distance increases significantly with elevation (see Fig. 6) with most of the cracks occurring above 1,770 m asl (Qi et al. 2004).

Fig. 8 Deep crack of SL24 with newly fractured segment with downward dislocation (After Qi et al. 2004)

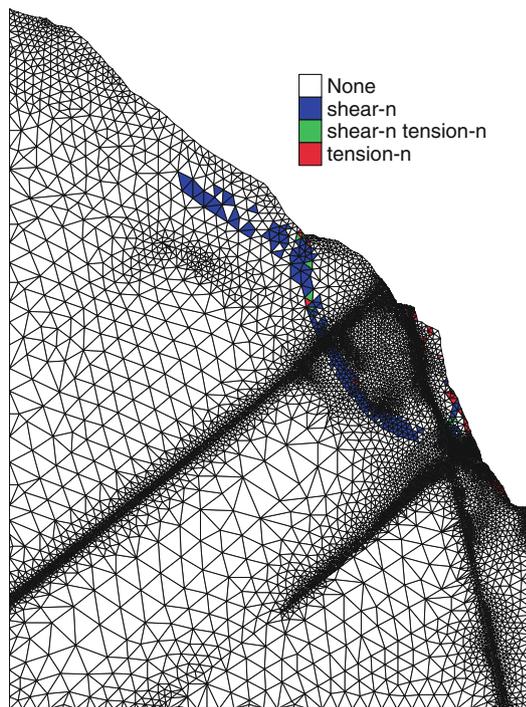
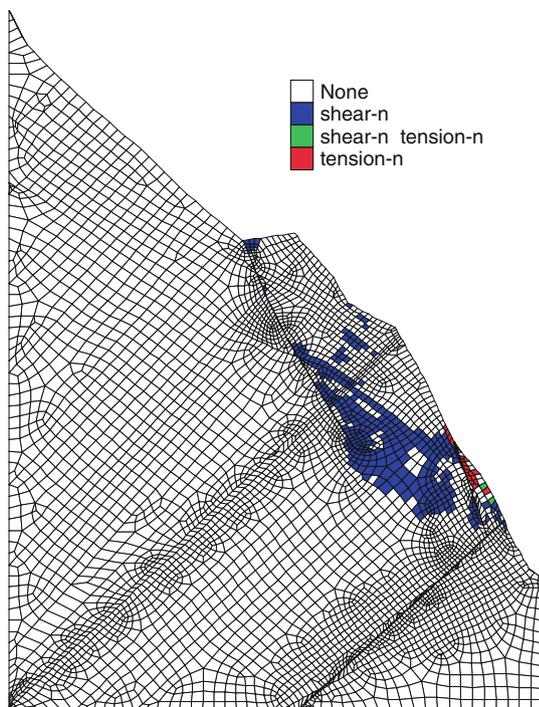
of the plastic zone distribution (Fig. 12) that the deep-seated cracks play a significant role in the location of the slide surface in sections VI-VI and IV-IV, as the inferred shear failure zones in both sections potentially indicate a high concentration of stress with a similar attitude and distribution as the deep cracks.

The calculations indicate that the left bank slope is not mathematically stable and to ensure its safety some remedial works will be necessary.

Fig. 12 The result reached by strength analysis based on FLAC^{3D}. **a** Cross section VI-VI. **b** Cross section IV-IV

To improve the stability of the left slope where the deep cracks are present, anchoring would not be practical in view of the distance in from the valley side. As a consequence cement infilling of special galleries and grouting was adopted to improve the quality of the rock mass. Three places with deep cracks (SL1, SL2 and SL3—see Fig. 5c) were chosen to check the effectiveness of the grouting
