Influence of deep seated discontinuities on the left slope of Jinping I Hydropower Station and its stability analysis

Shengwen Qi · Faquan Wu · Yuande Zhou ·
Yuhuan Song · Manfu Gong

Received: 23 April 2009 / Accepted: 12 January 2010 / Published online: 30 March 2010
© Springer-Verlag 2010

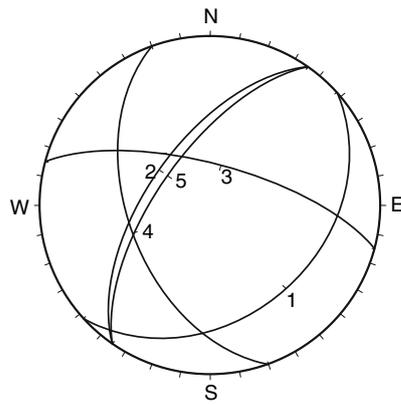
Fig. 4 Stereo net projection of four sets discontinuities and slope surface (Equal area, upper hemisphere)

The orientations/declinations of the four sets of discontinuities developed in the left slope are shown in Fig. 4.

- 1 — mean attitude of set ①, 318°∠34°;
- 2 — mean attitude of set ②, 125°∠65°;
- 3 — mean attitude of set ③, 195°∠70°;
- 4 — mean attitude of set ④, 70°∠50°;
- 5 — mean attitude of slope surface, 125°∠60°;

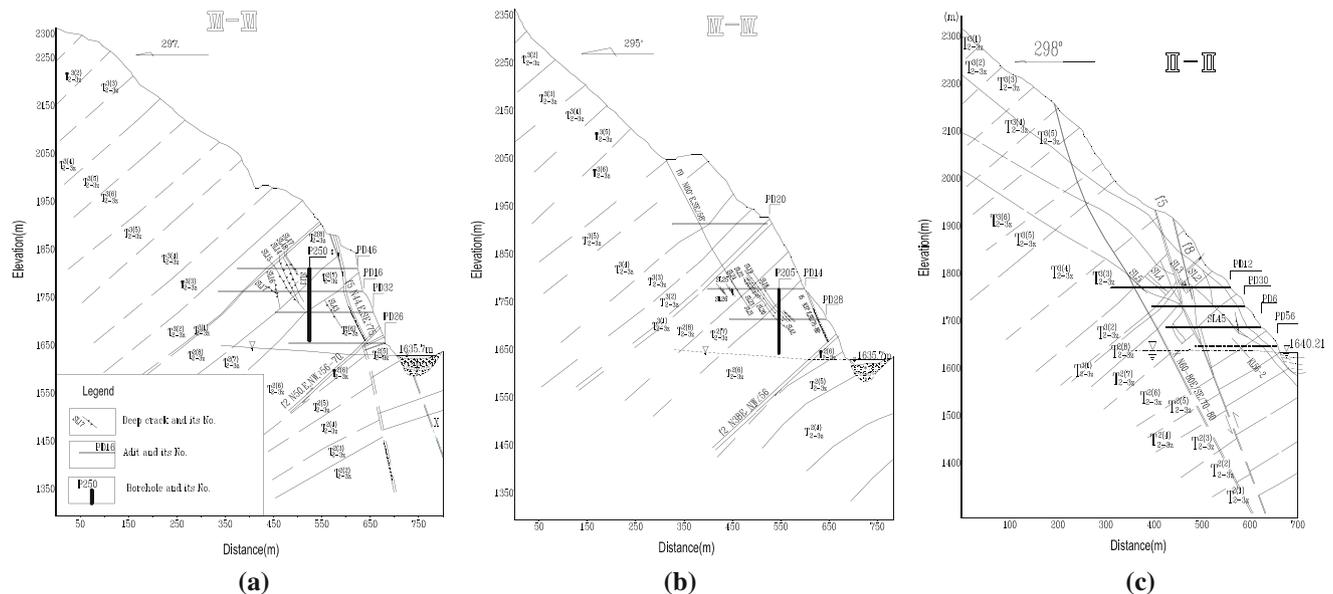
Fig. 5 Typical cross sections of the left bank slope: a VI-VI; b IV-IV; c II-II

In order to further investigate the deep seated discontinuities and evaluate their effect on the slope stability, a total of 29 exploration adits were excavated at different elevations (Fig. 5a–c).

Two typical cross sections (IV-IV and VI-VI) in which deep cracks had developed (Fig. 5a, b) were selected to evaluate the stability of the slope.

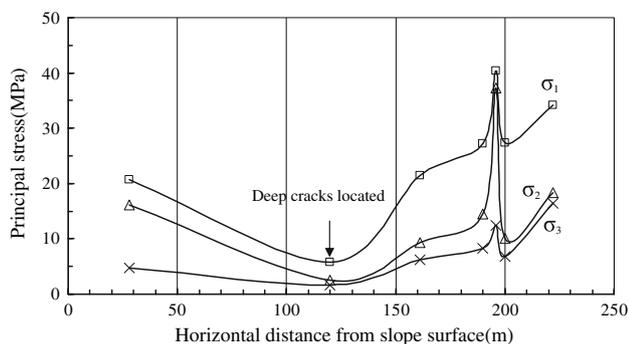
Fig. 9 The distribution of principal ground stress from the slope surface at a horizontal elevation of 1,830 m asl (After Institute of Chengdu Investigation and Design of National Electrical Power 2001)

- (e) Partly owing to the existence of deep cracks in the left bank, the ground stress shows large fluctuations with horizontal distance, increasing inwards from the valley side. For example, at 1,830 m asl (Fig. 9) the ground stress varies with a maximum primary stress of 27.1–40.4 MPa at a distance of 195 m from the slope surface although it drops quite suddenly at 200 m. At a distance of 120–130 m, the ground stress shows an obviously abnormally low magnitude of 5.84 MPa where deep cracks SL14 and SL15 are present. It is possible that the stress concentration at 195 m will form the locus of a future fracture.

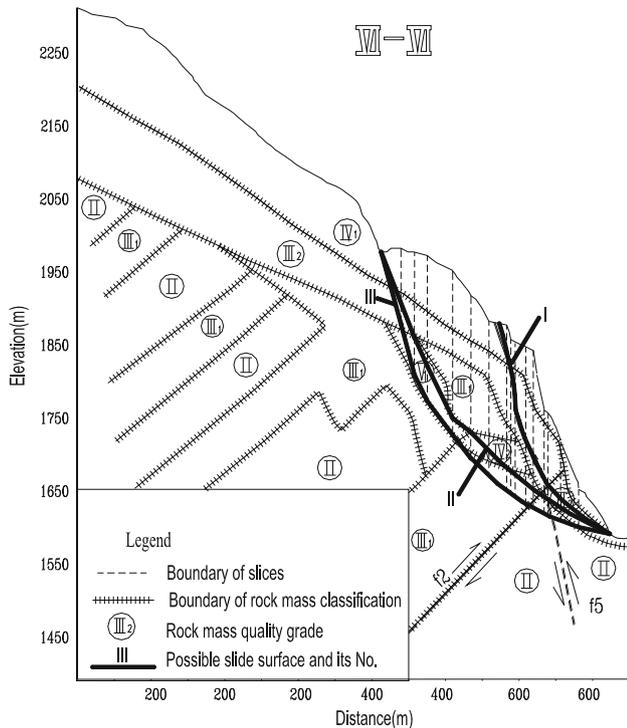
Fig. 10 Discretization of VI-VI cross section of the slope

Cross section	No. of critical surface	Possible critical surface	FOS
VI-VI	I	Part of f_5 + speculated segment	1.026
	II	Speculated segment + SL13-14 + speculated segment	1.118
	III	Speculated segment + SL15 + speculated segment	1.300
IV-IV	I	f_9 + SL22-20 + SL42 + speculated segment	1.053
	II	f_9 + SL24 + speculated segment	1.276

From the geological conditions in these cross sections, it is possible to identify a number of likely slide surfaces, as listed in Table 1 (see Figs. 10 and 11) where the rupture plane follows an almost circular line moving from crack to crack, i.e. not typical of a rock slope analysis.
